U.S. ENVIRONMENTAL PROTECTION AGENCY POLLUTION/SITUATION REPORT 2015 Gold King Mine Release SITREP

Subject: Situation Report #8

Gold King Mine Release San Juan County, CO

Date: 08/16/2015

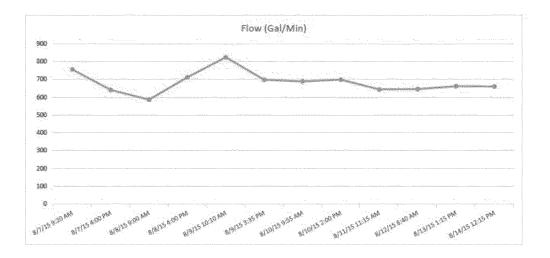
Flow from the mine through the morning of 8/14/2015 is shown in the following chart. The flow chart will be updated for the next SITREP. The treatment pond effluent pH on the afternoon of 8/13/2015 was 4.95.

Treated water from the last treatment pond is discharging into Cement Creek. Flow data out of the mine is being collected manually two times per day. Water quality data is being collected at the influent and effluent of the treatment system as well.

The EPA continues to operate four treatment and sedimentation ponds at the mine site which are treating water by lowering acidity levels and removing dissolved metals. A technical expert from CDPHE is assisting at the Gold King Mine site in optimizing the water quality treatment system.
